Z1000 Rear Master Cylinder –Rear Difficult To Bleed and Brake Binding

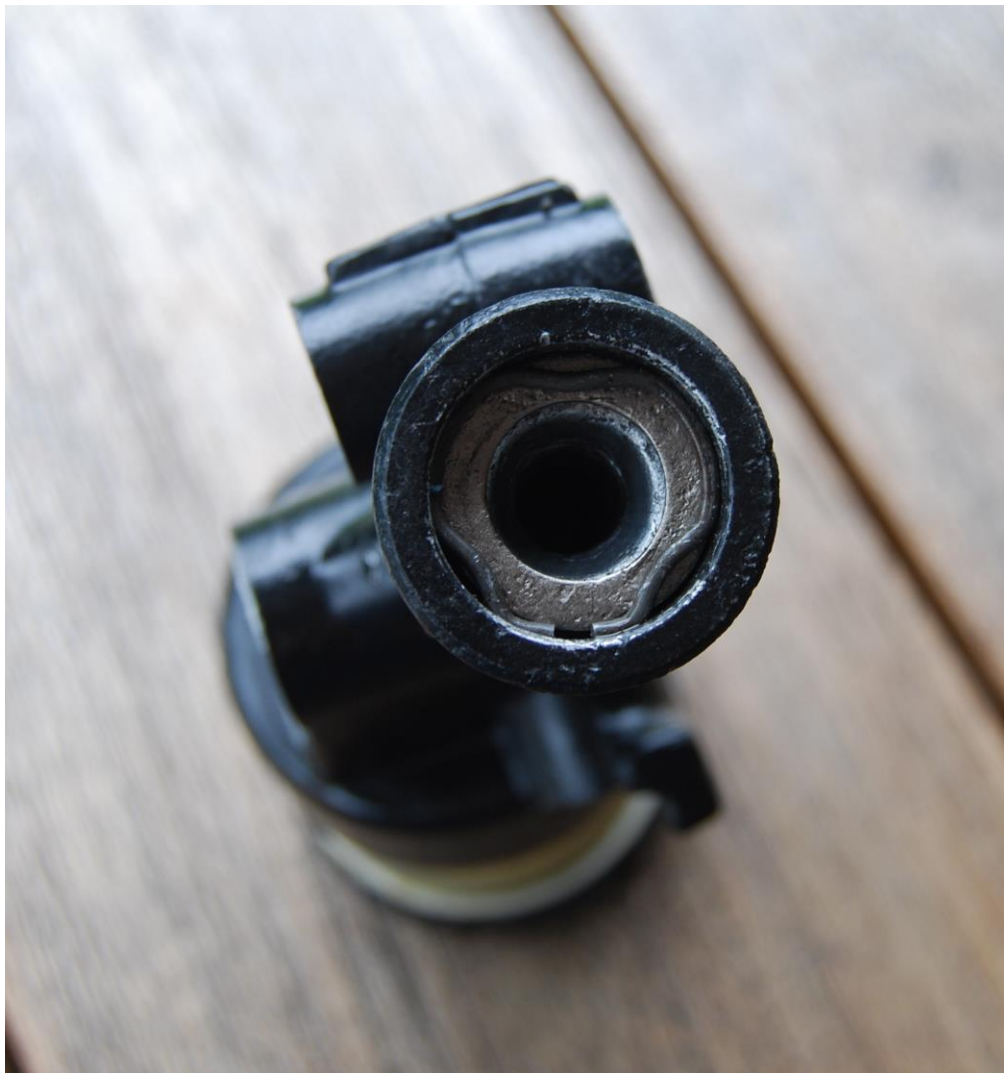
If you want to strip it down, the first challenge is getting the piston out (worth doing – we have had one that has snapped)

The clip and the washer are easy enough to remove, but the piston can be very stubborn. We have found that an M8 tap will fit in it very nicely. Having tapped it out, you can screw in an M8 bolt, put an impact wrench (if you have one) on the end of the bolt and give it a wiz. If you pull a bit at the same time the piston should come out. A little bit of heat may help but too much and you will certainly need a new seal.

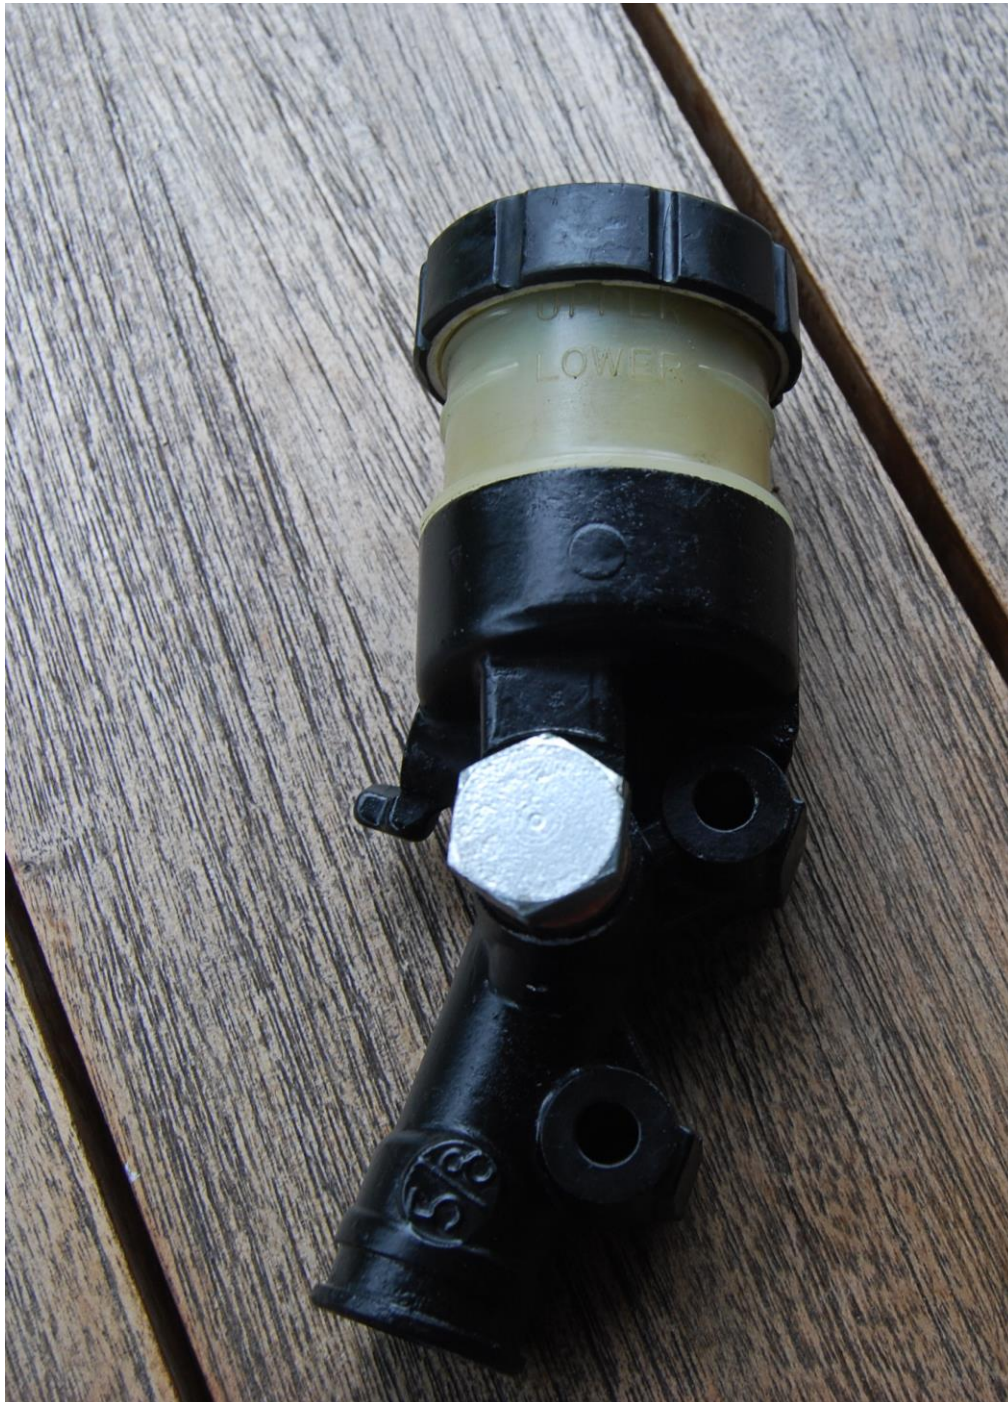
Having cleaned it up (we have them blasted and Xylon coated), re-zinc the hex bolt and reassemble – it should be as good as new !!
